PERFORMANCE OF AXIAL-FLOW SUPERSONIC COMPRESSOR

OF XJ55-FF-1 TURBOJET ENGINE

III - OVER-ALL PERFORMANCE OF COMPRESSOR

NACA RM SE9G19

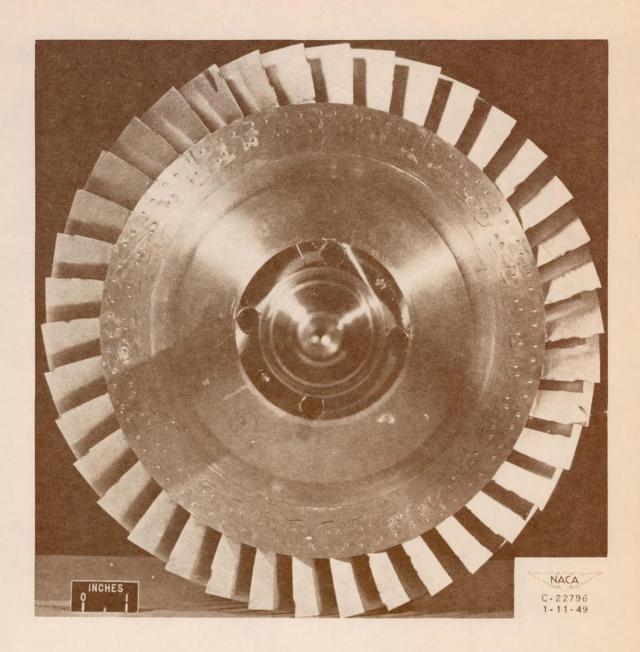
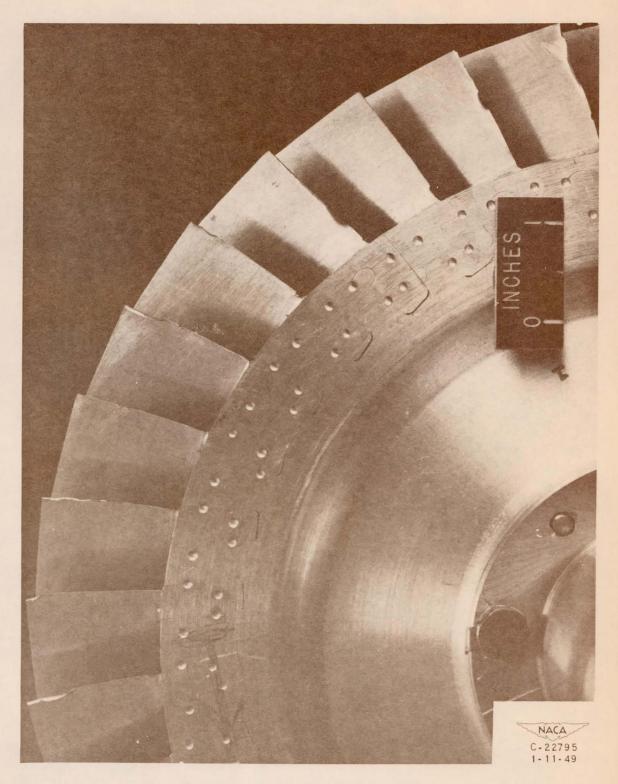
The compressor-rotor blades were made of high-strength aluminum alloy machined to leading-edge wedge angles varying from 8° to 12° (fig. 2). Numerous inspections of the compressor rotor were made during operation; after about 35 hours, considerable damage to the leading edges of the compressor-rotor blades was observed. This damage was in the form of a rolling-over of the thin leading edges (fig. 3(a)). As shown in the enlarged view (fig. 3(b)), no impact marks could be found on the rolled over portions of the blades. This damage is apparently the result of aerodynamic forces. Maximum steady-state aerodynamic forces would exert forces of the order of only one-fifth of the yield strength of this material. Thus it appears that the forces necessary to cause this damage would of necessity result from unsteady conditions, which could produce rather violent forces accompanying flows perpendicular to the sharp leading edges. The rolling-over of the edges eliminates a highfrequency vibration because such a vibration would break the aluminum sections.

Metallurgical examination showed that the material used in these blades had very strong directional characteristics. The crystalline structure of the blade examined was such that very poor fatigue life would result in direction of failure. This characteristic of the blade material was probably the cause of the increased extent of damage and the reduced operating time in the two failures, but it is not considered sufficient to explain the cause of this

(a) Entire rotor.
Figure 3. - Initial damage to compressor rotor.

(b) Enlarged view of section of rotor.
Figure 3. - Concluded. Initial damage to compressor rotor.

The rotor blades were reworked by hand-filing the damaged portions of the leading edges, thus moving back the leading edges but maintaining design area ratio and leading-edge angle. The compressor was operated for about 12 hours before similar damage was observed. The second damage was only a little more extensive than that shown in figure 3(a). The rotor blades were again refinished in the same manner; after refinishing, the compressor was operated for only about 2 hours when the more extensive damage shown in figure 4(a) was observed. As shown in the enlarged view (fig. 4(b)), the leading edges were again rolled over but in this case the damage extended along the entire length of the blade. After the two hand-filings and about 47 hours of operation, these portions of the blades had been considerably work-hardened, resulting in the more extensive damage.

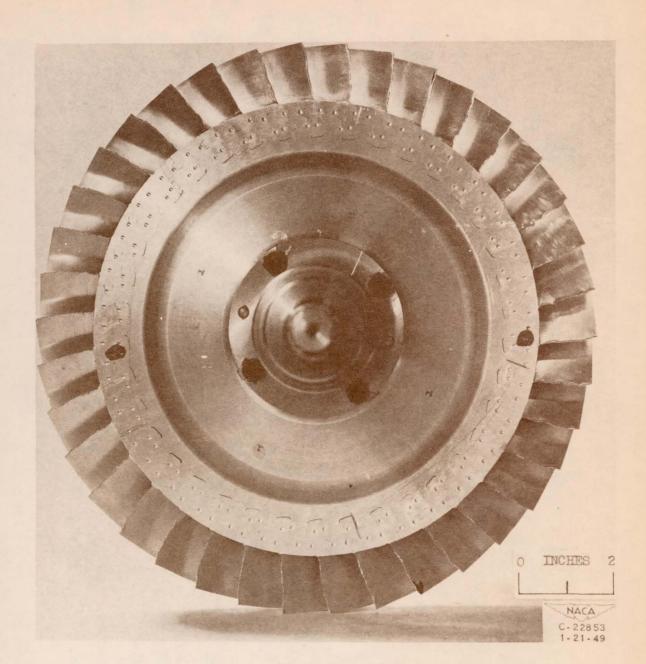
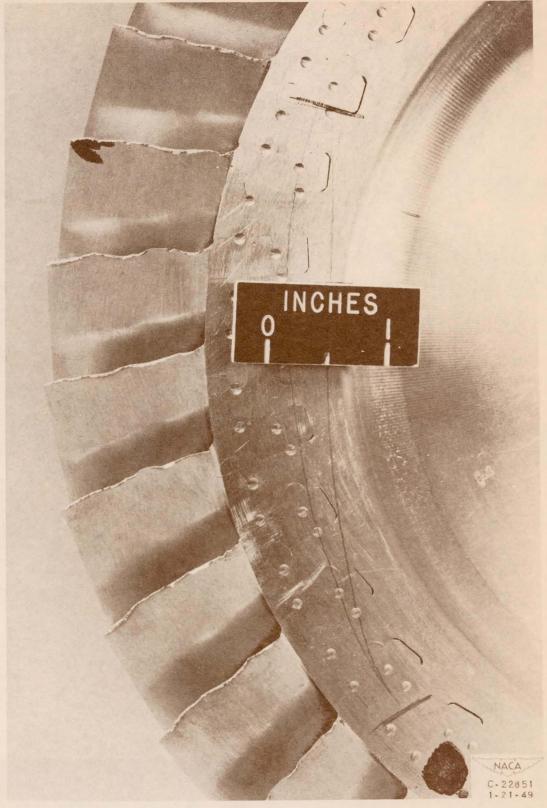
(a) Entire rotor.
Figure 4. - Final condition of compressor rotor.

(b) Enlarged view of section of rotor.
Figure 4. - Concluded. Final condition of compressor rotor.
